# Building Inspection Report

**5678 Main St. Any Town USA**

**Inspection Date:**  
5/31/07

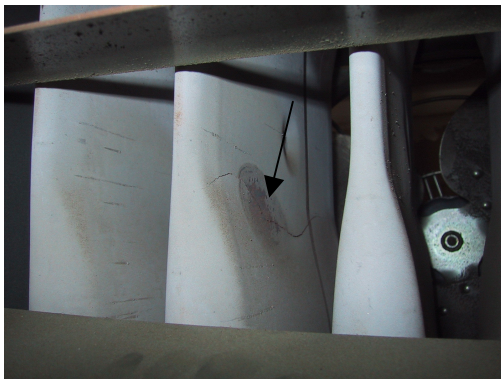
**Repair: Major Concern:** The heat exchanger on the unit heater is cracked. This will allow the by-products of combustion to escape the exchanger and spill into the garage. This unit needs to be replaced. Contact a qualified HVAC tech for repairs.

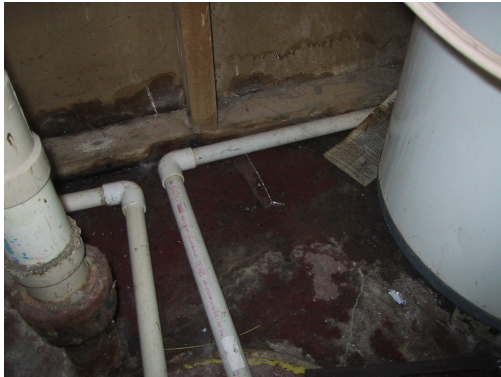
**Repair:** The Rheem water heater is leaking. Water was found pooling underneath and behind this water heater. Contact a qualified plumber to replace this water heater.

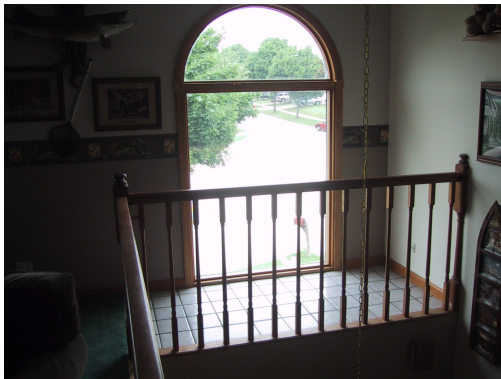
**Repair: Safety Issue:** The floor mounted plate glass window in the loft is a potential safety concern for a few reasons. One concern is that the window does not seem to be safety glazed or tempered (I could not find the safety glazing stamp on the glass. The only way to find out if it's safety glazed without the stamp is to either find the original paperwork or work order for the window or to break the glass). The other concern is with the window being at floor level, someone could easily fall through the glass. At this point I recommend contacting a qualified window installer or glazer to determine if the glass is safety glazed or tempered and to add some sort of fall protection in front of the window opening.

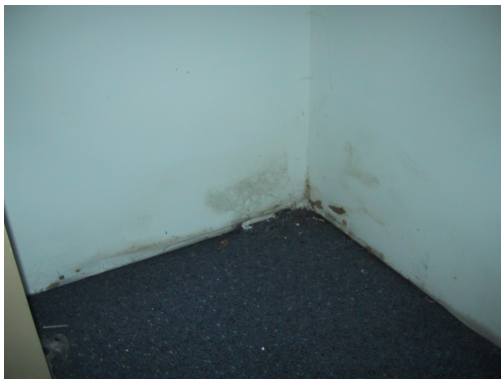
**Repair:** There was a small water stained area along the NW corner of the basement (in the closet along the front of the basement). The area was dry during the inspection, but when I probed the area with an awl, I found rotted wood along the bottom of the wall. This tells me that this staining is not a one-time occurrence. I recommend opening the wall in this area to view the foundation wall. If any cracks are found they would have to be sealed (cracks in concrete is normal, but they can seep). Contact a qualified water proofing company for repairs.
