HOME INSPECTIONS, INC.

Building Inspection Report

555 Main St. Anywhere, USA

Inspection Date:
4/28/2015

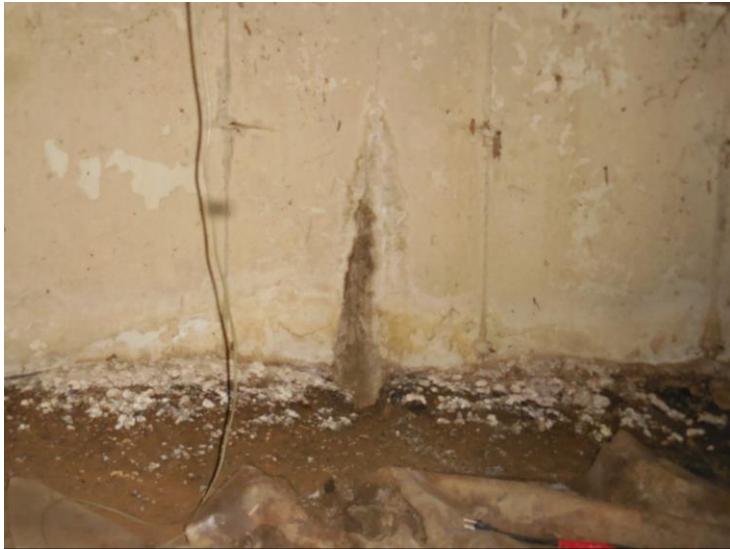
A few seeping cracks were found along the back wall of the crawlspace.

Repair: Two active seepage cracks were found along the back wall of the crawlspace. Signs of moisture were on the wall and on the crawlspace floor under the cracks.

This type and pattern of cracking is usually the result of concrete shrinkage as it cures and are very common and normal on concrete foundations. The one problem with these types of cracks is that they may leak. I recommend contacting a qualified waterproofing company for repairs. The only type of repair that I recommend is epoxy injection. This repair is fairly costly, but is considered permanent and companies that perform this repair usually offer lifetime warranties.

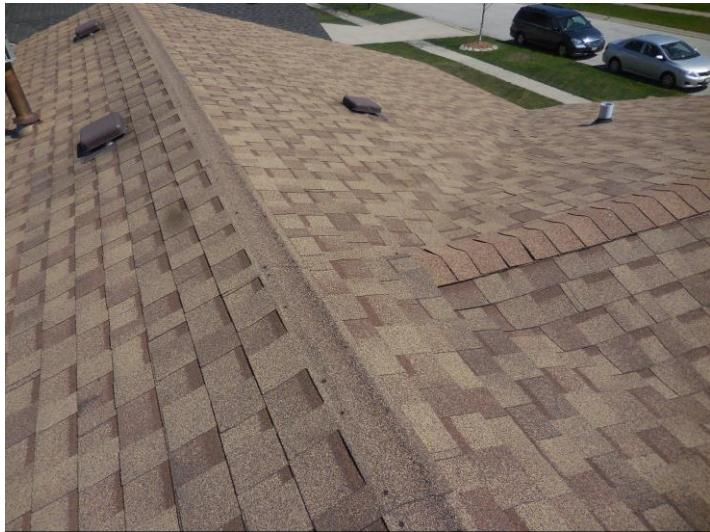
The ridge cap shingles are missing along the entire length of the main roof.

Repair: The ridge cap shingles for the main section of the roof are missing and need to be installed. It's needed to seal the ridge and to prevent water from entering the building. Contact a qualified roofing contractor for repairs.

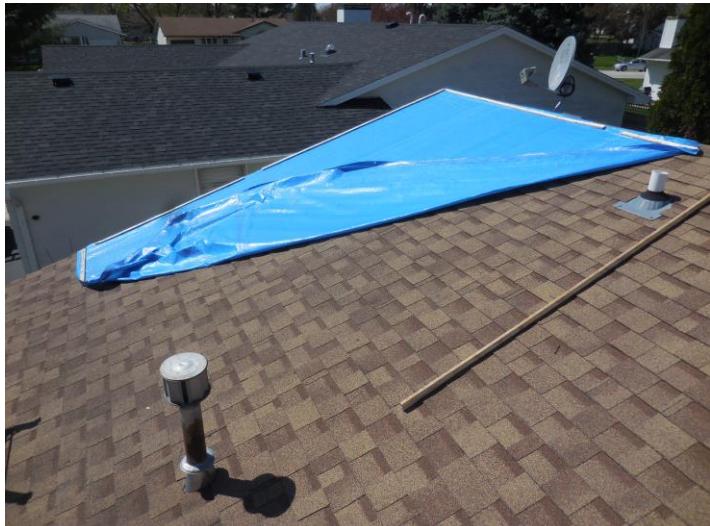
I do not know why the tarp was installed. I was able to partially remove it to view some of the area. It needs to be completely removed and repaired if needed.

Repair: There is a large blue tarp that is installed on the roof of the building, directly over the garage. I was able to unscrew some of the wood boards that are holding in place to partially view under tarp and I could not see anything that was out of the ordinary. The shingles were installed and the roof deck was solid. I was also able to access the attic directly under this area and could not locate any leaking.

I recommend completely removing the tarp to view the entire area. I do not know why this area was covered, but one guess could be because of a leak coming in from the area where the ridge cap is missing and someone mistakenly thought it was from the garage roof area.

If there are no other problems found when the tarp is removed, all of the screw holes from the wood boards need to be sealed or the shingles replaced if you can match the shingles.

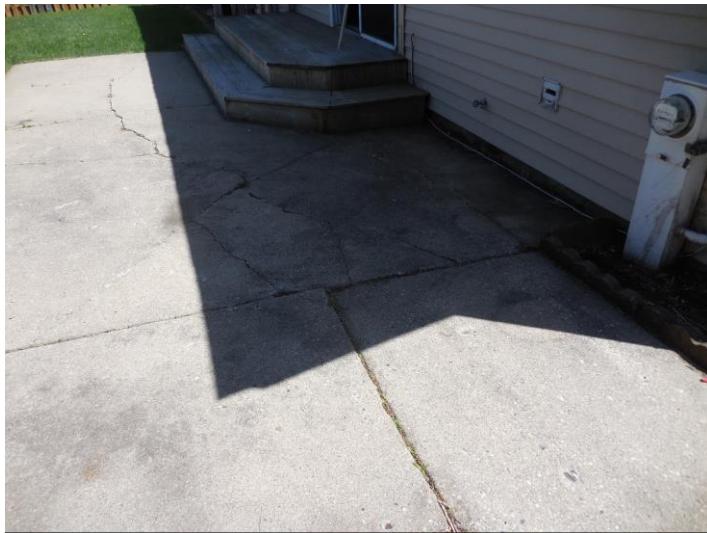
The concrete patio is cracked and displaced and needs to be removed.

Major Concern: Repair: The concrete patio has settled, creating a displacement in the center that can be considered a tripping hazard. Also it's back-pitched towards the building. This will cause water, snow and ice to drain near the foundation.

At this point it looks as if this patio would not be a good candidate for concrete raising. I recommend contacting a qualified concrete contractor to remove and replace this patio.

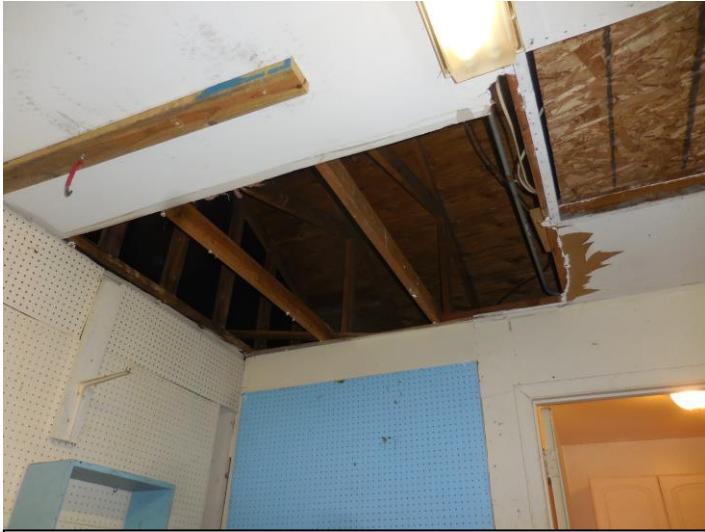
Safety Issue: Repair: The back of the garage ceiling is wide open the attic area above the building. This section of the garage ceiling needs to be enclosed to create a fire separation between the garage and attic. The idea is to prevent or slow the spread of a fire from the garage to the roof structure.

The garage ceiling needs to be repaired.

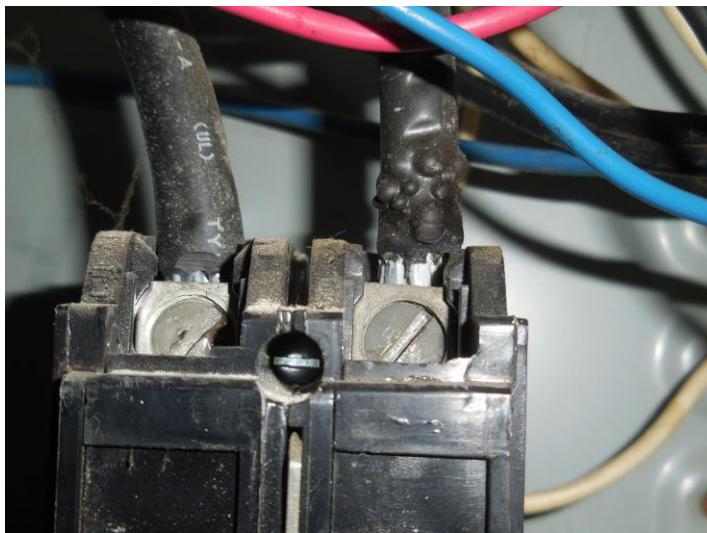
Safety Issue: Repair: The insulation on the right hand side aluminum service entrance cable (SEC) has melted. This side of the SEC overheated for some reason; either from missing its anti-oxidation paste or from a loose connection. Contact a qualified electrician to find out what caused this and to repair it as needed.

The insulation of this service entrance cable overheated and melted for some reason.

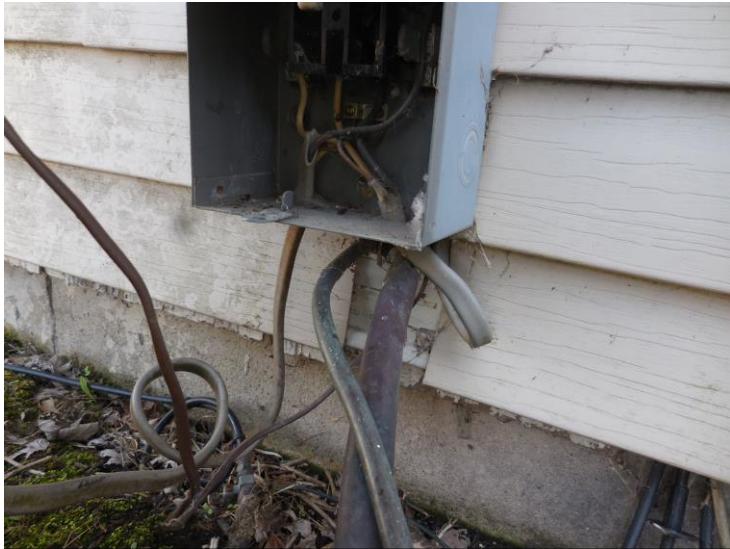
Safety Issue: Repair: A non-professional installation was found at the circuit for the central AC unit. The installer used non-metallic cable (Romex), which is typically not allowed in this jurisdiction and failed to use the proper cable connectors at the electrical panel and the service disconnect near the unit. Also the cable is wedged between the siding and the service disconnect housing where it extends into the crawlspace where it loosely extends towards the electrical panel.

Non-professional wiring was found at the circuit for the central AC system.

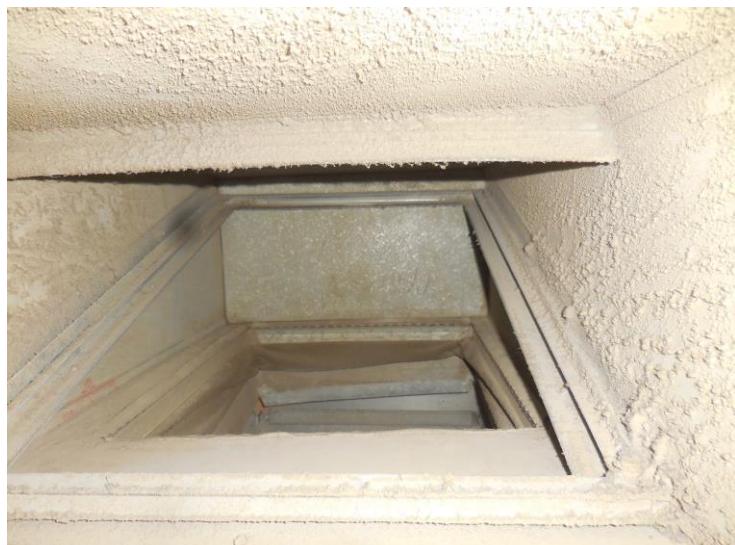
Repair: The return duct on top of the furnace is loose and needs to be re-secured in place. I was able to open the return grill located on the hallway wall in front of the furnace room and see a fairly large open gap along the back of the return duct. When this is being repaired, you may want to ask the HVAC tech if there is any way a filter slot can be added on the return duct inside of the furnace room. The current location of the filter is very inconvenient.

The return duct above the furnace needs to be re-secured in place and cleaned.

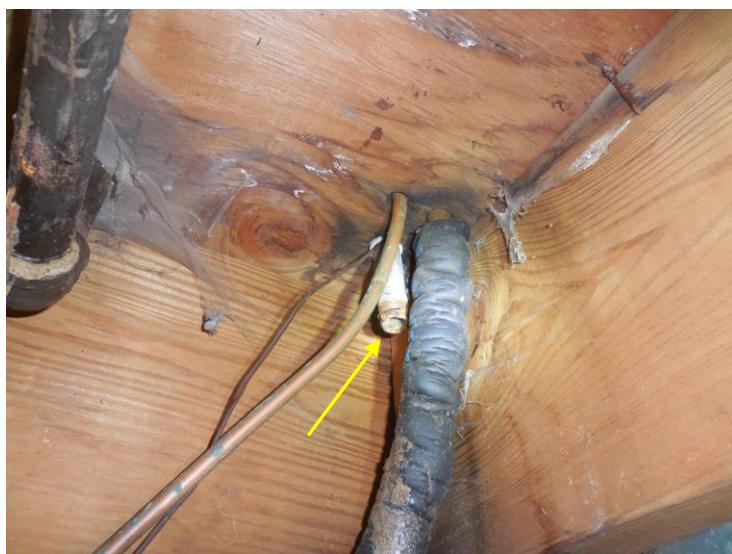
Repair: A condensate line needs to be installed to direct water either to the sump pump in the crawlspace or to the exterior of the building. Currently the condensate line is just stubbed into the crawlspace and spills water on the crawlspace floor. Contact a qualified HVAC tech for repairs.

The condensate line for the AC system needs to be re-routed either outside or to the sump pit in the crawlspace.

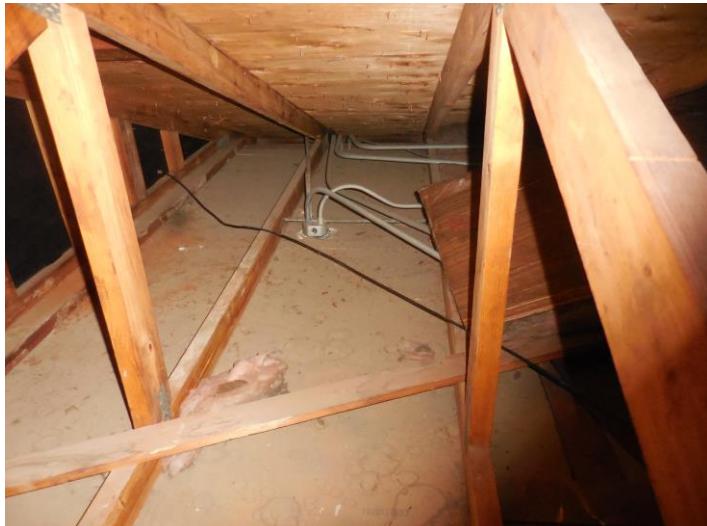
Repair: There is no insulation at all over the laundry room. This area needs to be properly insulated.

The insulation over the laundry room is missing and needs to be replaced.

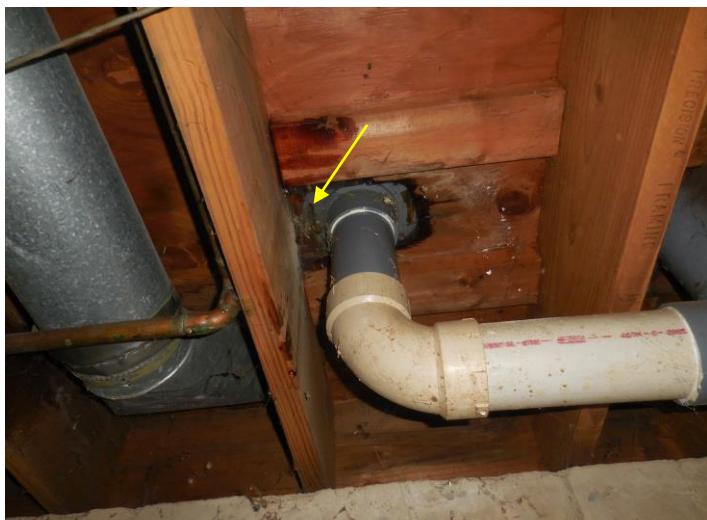
Repair: The toilet in this bathroom is leaking. Water was found streaming out from the toilet flange when the fixture was flushed (viewed from the crawlspace). Contact a qualified plumber for repairs.

Water spilled out from underneath the flange when the master bathroom toilet was flushed

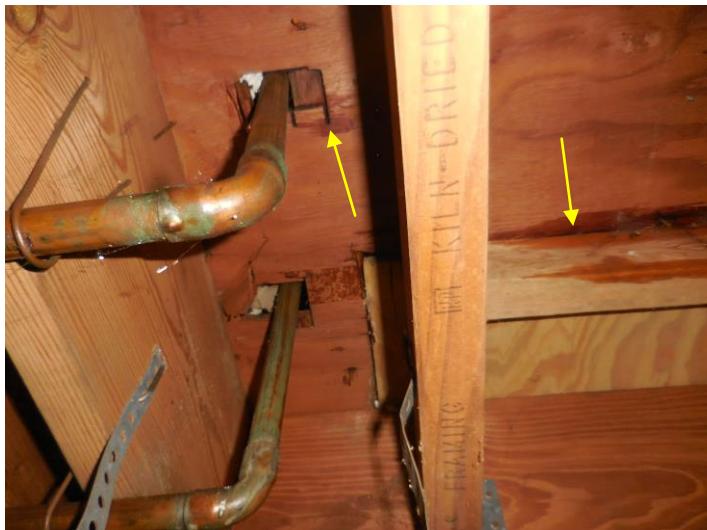
Repair: Water was found leaking into the crawlspace from the area where the water lines to the mixing valve for the tub/shower stall stub through the floor structure. It looks as if there may be a problem with the mixing valve or the piping to the mixing valve. Contact a qualified plumber for repairs.

The sub-floor was wet around the water lines to the tub/shower stall in the hall bathroom.

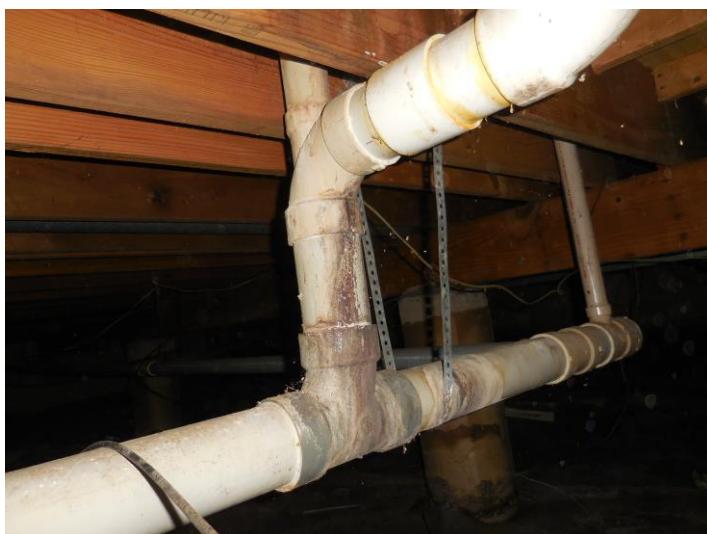
Repair: The water supply to the toilet in this bathroom was off during the inspection and the toilet was very loose. This fixture could be easily swayed from side to side. Also judging by the water staining on the waste line for this toilet in the crawlspace, this toilet may be leaking.

The water supply was off to the hall bathroom toilet, but it's apparent that it leaked in the past and may still be leaking

This repair may be as simple as removing the toilet, replacing the wax seal and securing the toilet back into place or as difficult as replacing a broken toilet flange. A qualified plumber should repair this toilet.
