HOME INSPECTIONS, INC.

Building Inspection Report

555 Main St. Anywhere, USA

Inspection Date:
4/28/2015

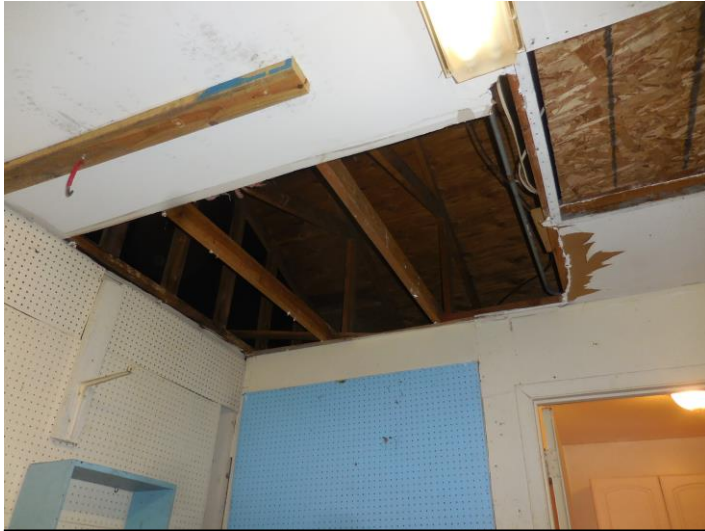
Safety Issue: Repair: The back of the garage ceiling is wide open the attic area above the building. This section of the garage ceiling needs to be enclosed to create a fire separation between the garage and attic. The idea is to prevent or slow the spread of a fire from the garage to the roof structure.

The garage ceiling needs to be repaired.

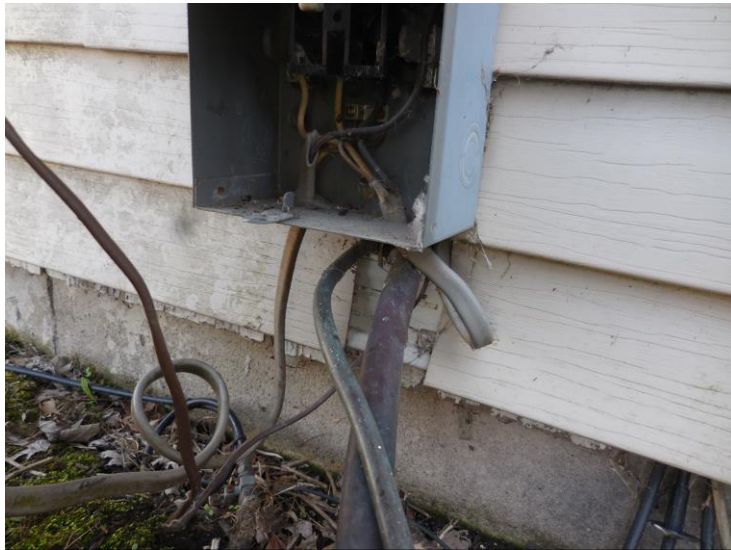
Safety Issue: Repair: A non-professional installation was found at the circuit for the central AC unit. The installer used non-metallic cable (Romex), which is typically not allowed in this jurisdiction and failed to use the proper cable connectors at the electrical panel and the service disconnect near the unit. Also the cable is wedged between the siding and the service disconnect housing where it extends into the crawlspace where it loosely extends towards the electrical panel.

Non-professional wiring was found at the circuit for the central AC system.

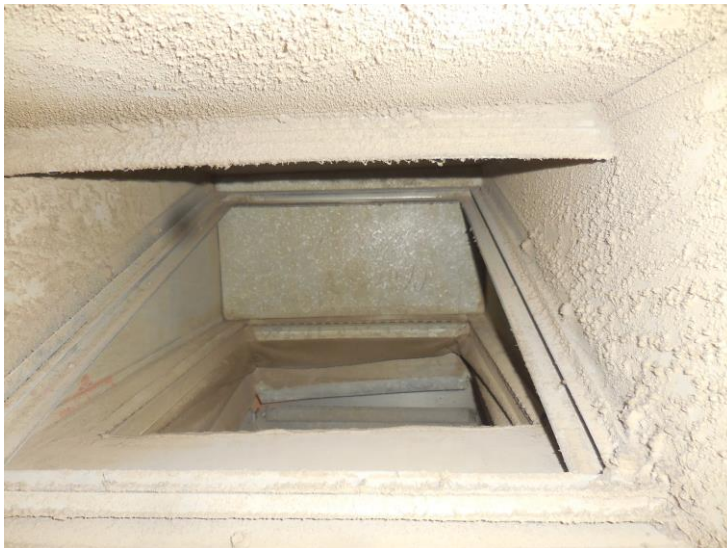
Repair: The return duct on top of the furnace is loose and needs to be re-secured in place. I was able to open the return grill located on the hallway wall in front of the furnace room and see a fairly large open gap along the back of the return duct. When this is being repaired, you may want to ask the HVAC tech if there is any way a filter slot can be added on the return duct inside of the furnace room. The current location of the filter is very inconvenient.

The return duct above the furnace needs to be re-secured in place and cleaned.

gap along the back of the return duct.

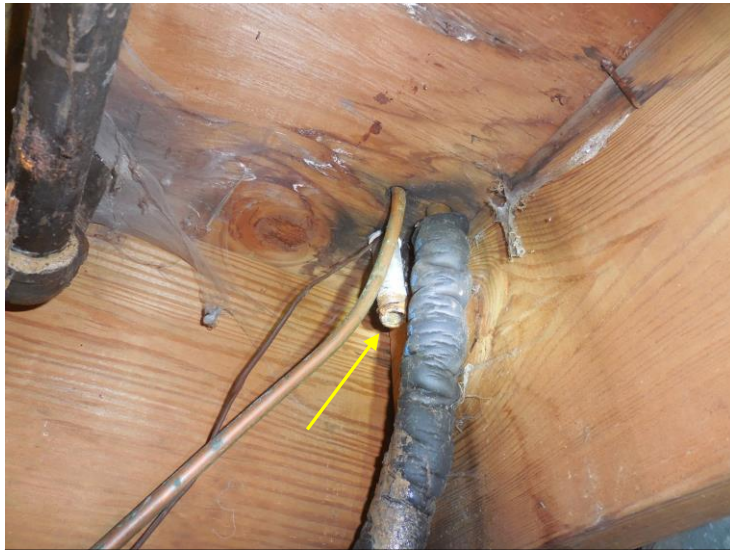
Repair: A condensate line needs to be installed to direct water either to the sump pump in the crawlspace or to the exterior of the building. Currently the condensate line is just stubbed into the crawlspace and spills water on the crawlspace floor. Contact a qualified HVAC tech for repairs.

The condensate line for the AC system needs to be re-routed either outside or to the sump pit in the crawlspace.

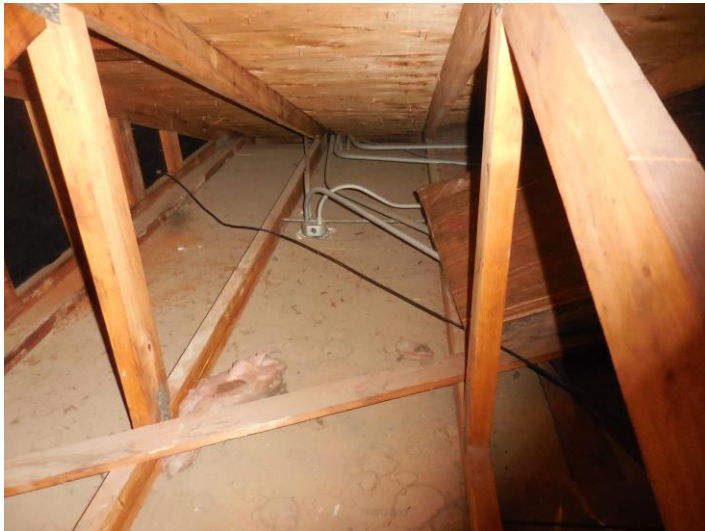
Repair: There is no insulation at all over the laundry room. This area needs to be properly insulated.

The insulation over the laundry room is missing and needs to be replaced.

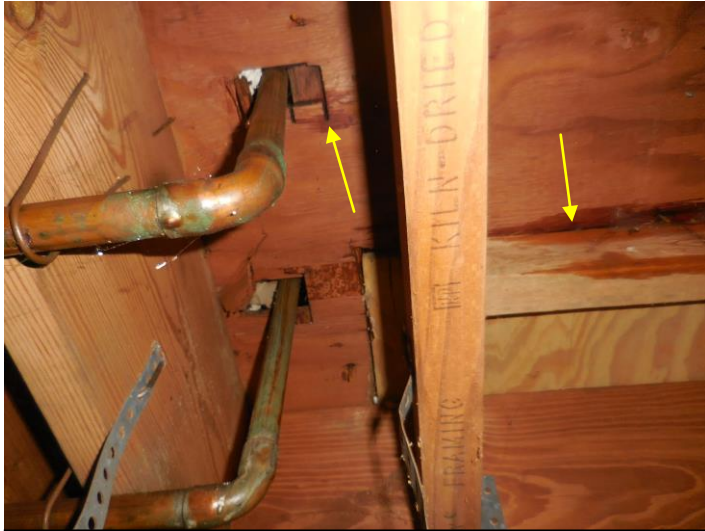
Repair: Water was found leaking into the crawlspace from the area where the water lines to the mixing valve for the tub/shower stall stub through the floor structure. It looks as if there may be a problem with the mixing valve or the piping to the mixing valve. Contact a qualified plumber for repairs.

The sub-floor was wet around the water lines to the tub/shower stall in the hall bathroom.

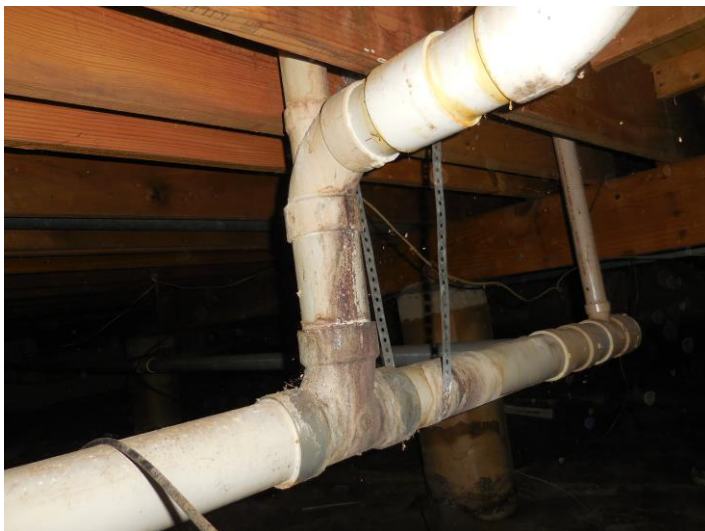
Repair: The water supply to the toilet in this bathroom was off during the inspection and the toilet was very loose. This fixture could be easily swayed from side to side. Also judging by the water staining on the waste line for this toilet in the crawlspace, this toilet may be leaking.

The water supply was off to the hall bathroom toilet, but it's apparent that it leaked in the past and may still be leaking

This repair may be as simple as removing the toilet, replacing the wax seal and securing the toilet back into place or as difficult as replacing a broken toilet flange. A qualified plumber should repair this toilet.
