HOME INSPECTIONS, INC.

Building Inspection Report

555 Main St. Anywhere, USA

Inspection Date:
4/28/2015

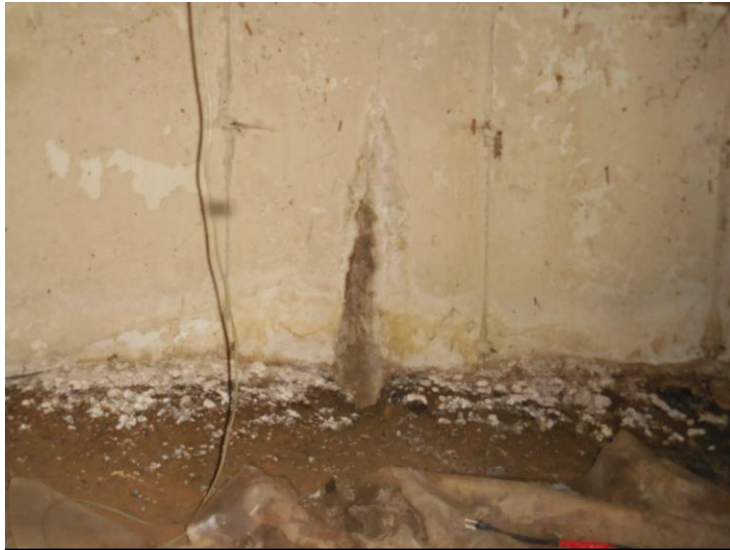
A few seeping cracks were found along the back wall of the crawlspace.

Repair: Two active seepage cracks were found along the back wall of the crawlspace. Signs of moisture were on the wall and on the crawlspace floor under the cracks.

This type and pattern of cracking is usually the result of concrete shrinkage as it cures and are very common and normal on concrete foundations. The one problem with these types of cracks is that they may leak. I recommend contacting a qualified waterproofing company for repairs. The only type of repair that I recommend is epoxy injection. This repair is fairly costly, but is considered permanent and companies that perform this repair usually offer lifetime warranties.

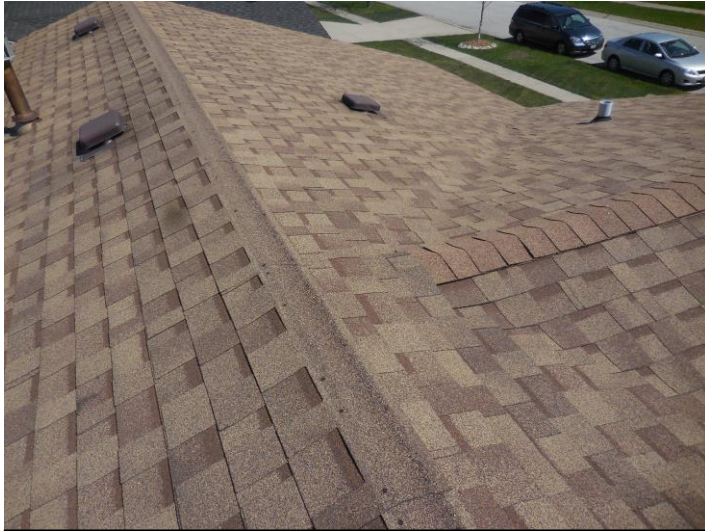
The ridge cap shingles are missing along the entire length of the main roof.

Repair: The ridge cap shingles for the main section of the roof are missing and need to be installed. It's needed to seal the ridge and to prevent water from entering the building. Contact a qualified roofing contractor for repairs.

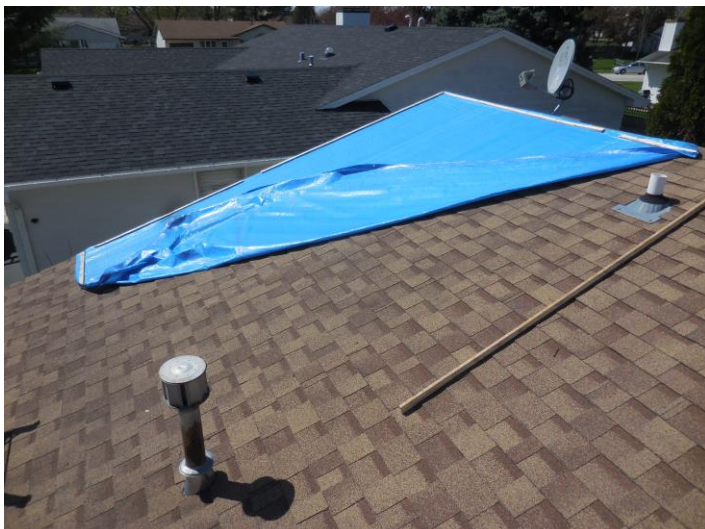
I do not know why the tarp was installed. I was able to partially remove it to view some of the area. It needs to be completely removed and repaired if needed.

Repair: There is a large blue tarp that is installed on the roof of the building, directly over the garage. I was able to unscrew some of the wood boards that are holding in place to partially view under tarp and I could not see anything that was out of the ordinary. The shingles were installed and the roof deck was solid. I was also able to access the attic directly under this area and could not locate any leaking.

I recommend completely removing the tarp to view the entire area. I do not know why this area was covered, but one guess could be because of a leak coming in from the area where the ridge cap is missing and someone mistakenly thought it was from the garage roof area.

If there are no other problems found when the tarp is removed, all of the screw holes from the wood boards need to be sealed or the shingles replaced if you can match the shingles.

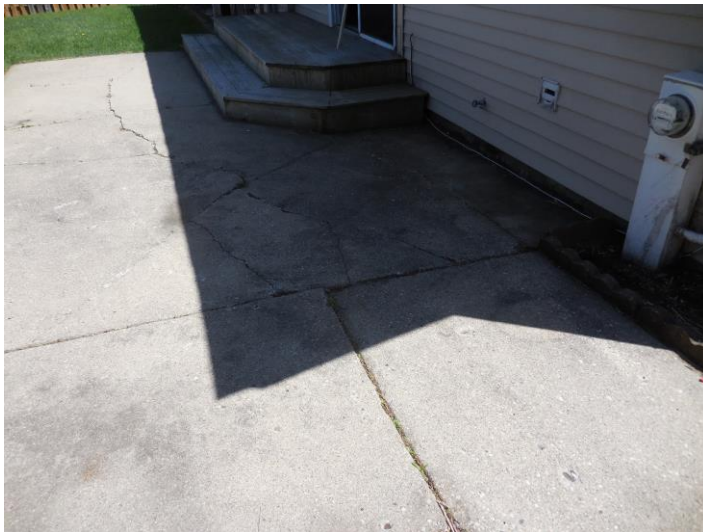
The concrete patio is cracked and displaced and needs to be removed.

At this point it looks as if this patio would not be a good candidate for concrete raising. I recommend contacting a qualified concrete contractor to remove and replace this patio.

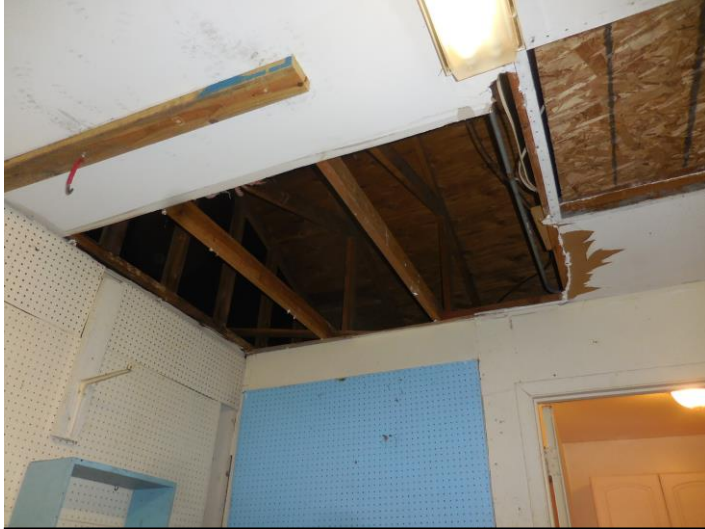
Safety Issue: Repair: The back of the garage ceiling is wide open the attic area above the building. This section of the garage ceiling needs to be enclosed to create a fire separation between the garage and attic. The idea is to prevent or slow the spread of a fire from the garage to the roof structure.

The garage ceiling needs to be repaired.

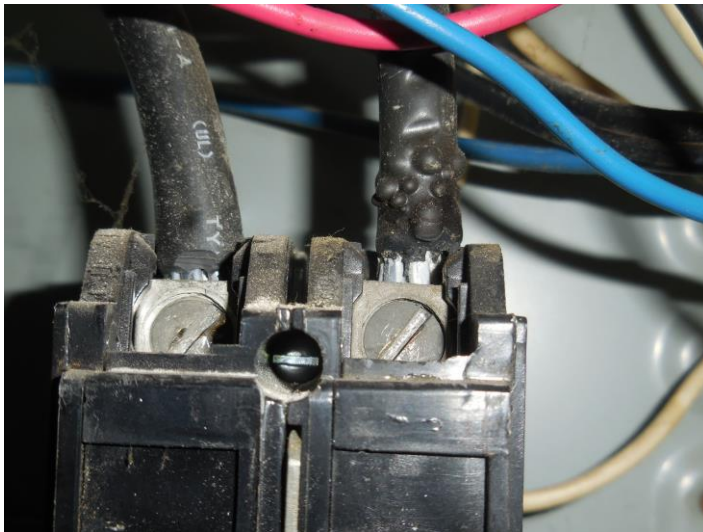
Safety Issue: Repair: The insulation on the right hand side aluminum service entrance cable (SEC) has melted. This side of the SEC overheated for some reason; either from missing its anti-oxidation paste or from a loose connection. Contact a qualified electrician to find out what caused this and to repair it as needed.

The insulation of this service entrance cable overheated and melted for some reason.

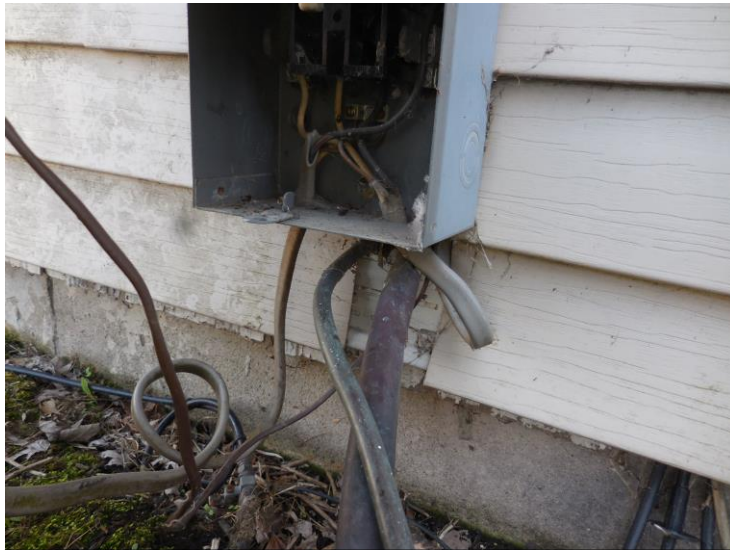
Safety Issue: Repair: A non-professional installation was found at the circuit for the central AC unit. The installer used non-metallic cable (Romex), which is typically not allowed in this jurisdiction and failed to use the proper cable connectors at the electrical panel and the service disconnect near the unit. Also the cable is wedged between the siding and the service disconnect housing where it extends into the crawlspace where it loosely extends towards the electrical panel.

Non-professional wiring was found at the circuit for the central AC system.

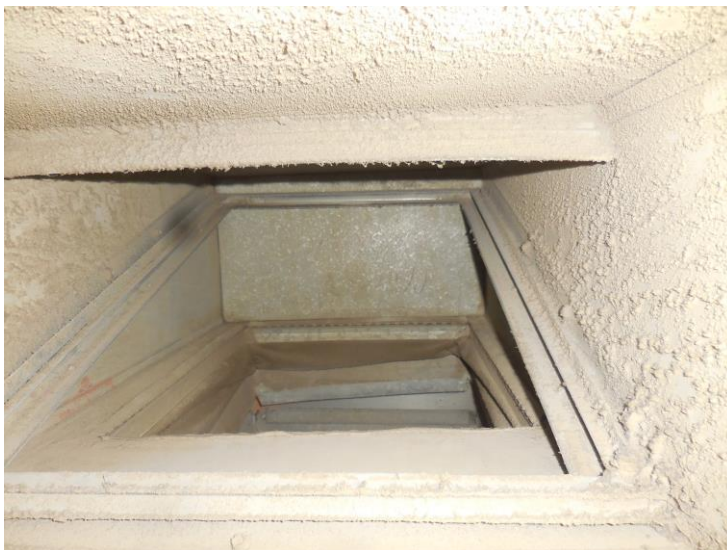
Repair: The return duct on top of the furnace is loose and needs to be re-secured in place. I was able to open the return grill located on the hallway wall in front of the furnace room and see a fairly large open gap along the back of the return duct. When this is being repaired, you may want to ask the HVAC tech if there is any way a filter slot can be added on the return duct inside of the furnace room. The current location of the filter is very inconvenient.

The return duct above the furnace needs to be re-secured in place and cleaned.

gap along the back of the return duct.

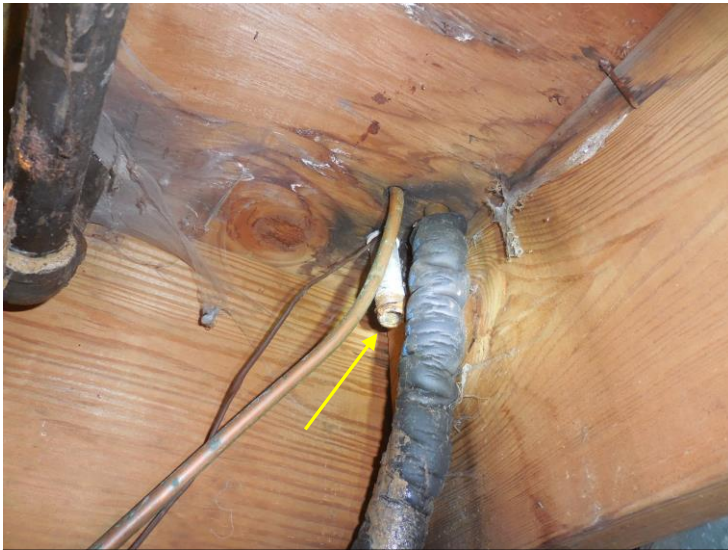
Repair: A condensate line needs to be installed to direct water either to the sump pump in the crawlspace or to the exterior of the building. Currently the condensate line is just stubbed into the crawlspace and spills water on the crawlspace floor. Contact a qualified HVAC tech for repairs.

The condensate line for the AC system needs to be re-routed either outside or to the sump pit in the crawlspace.

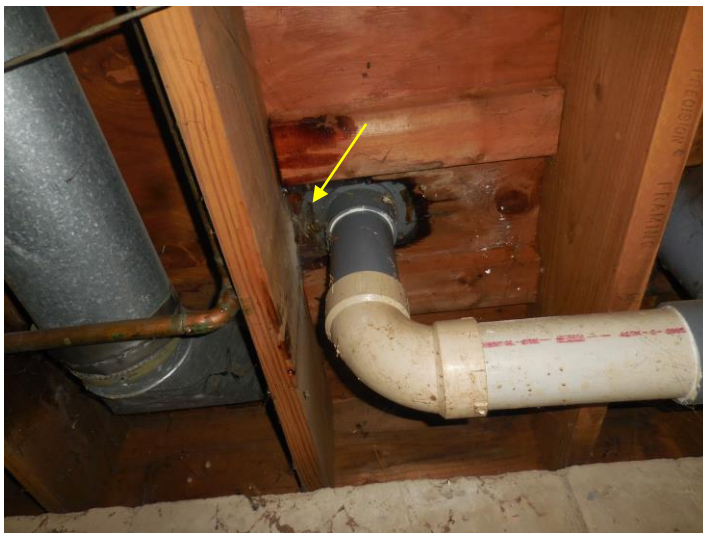
Repair: The toilet in this bathroom is leaking. Water was found streaming out from the toilet flange when the fixture was flushed (viewed from the crawlspace). Contact a qualified plumber for repairs.

Water spilled out from underneath the flange when the master bathroom toilet was flushed

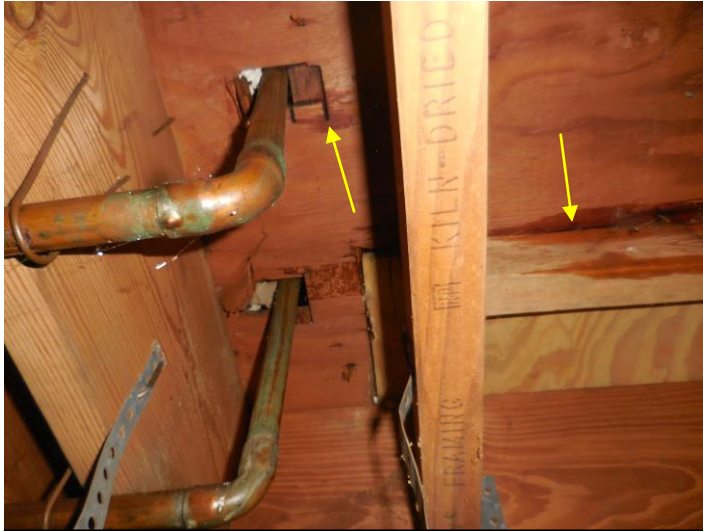
Repair: Water was found leaking into the crawlspace from the area where the water lines to the mixing valve for the tub/shower stall stub through the floor structure. It looks as if there may be a problem with the mixing valve or the piping to the mixing valve. Contact a qualified plumber for repairs.

The sub-floor was wet around the water lines to the tub/shower stall in the hall bathroom.

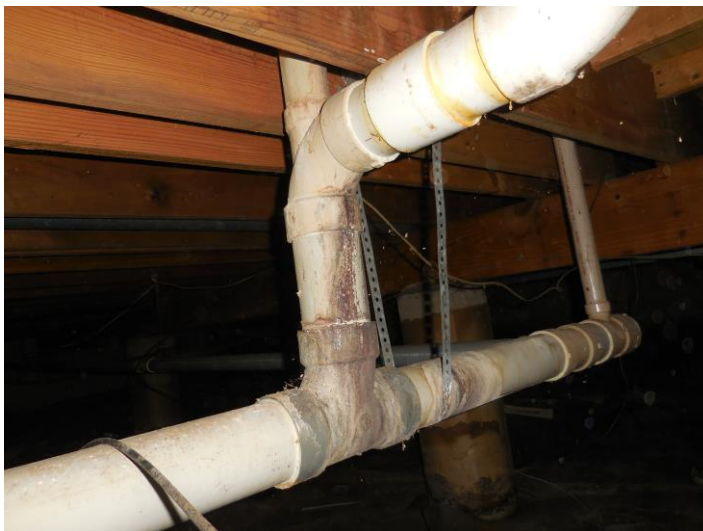
Repair: The water supply to the toilet in this bathroom was off during the inspection and the toilet was very loose. This fixture could be easily swayed from side to side. Also judging by the water staining on the waste line for this toilet in the crawlspace, this toilet may be leaking.

The water supply was off to the hall bathroom toilet, but it's apparent that it leaked in the past and may still be leaking

This repair may be as simple as removing the toilet, replacing the wax seal and securing the toilet back into place or as difficult as replacing a broken toilet flange. A qualified plumber should repair this toilet.
