HOME INSPECTIONS, INC.

Building Inspection Report

1010 Main St. Anywhere, USA

Inspection Date:
2/17/2015

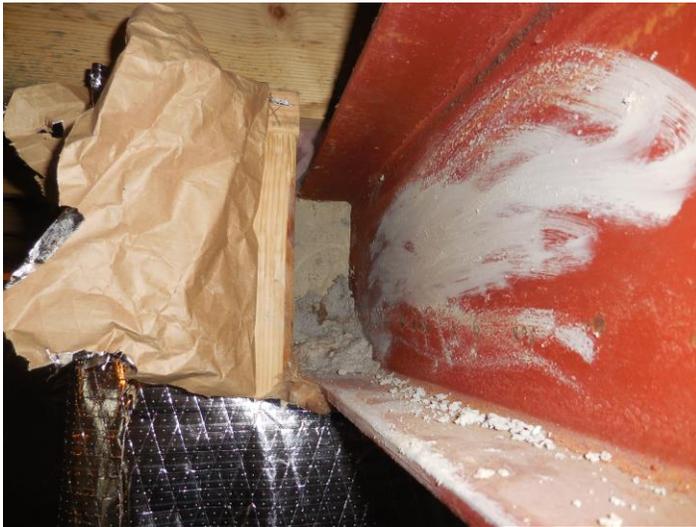
In this case, someone made a half-hearted attempt to fill the beam pocket, with some being only a quarter filled. If this is required, which it appears that is, the beam pocket needs to be completely filled.

Someone made a poor attempt to grout this beam in its beam pocket. If it needs to be grouted, it needs to be filled top to bottom.

Repair: Most jurisdictions require the area around the support beams to be grouted in place where the beams sit inside their beam pockets on the foundation walls. This helps prevent shifting and rotation of the support beams.

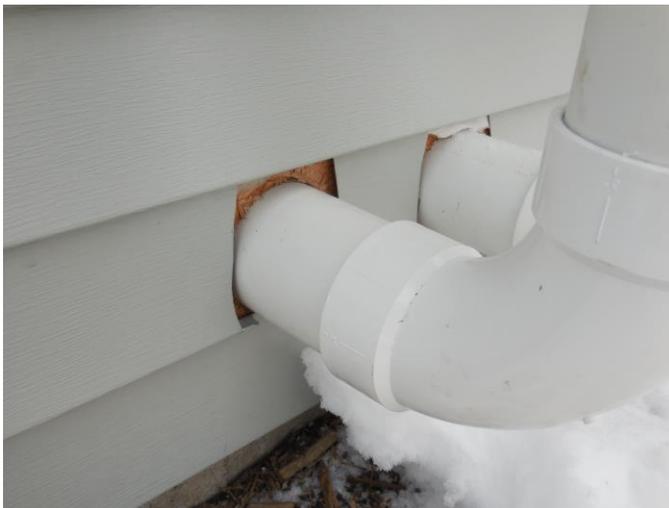
The siding around the furnace intake and exhaust needs to be replaced.

Repair: The vinyl siding around the exhaust and intake pipes for the furnace and the exhaust pipe for the water heater needs to be replaced. The installer over-cut around these pipes, leaving gaps large enough to expose the sheathing and gaps to big to caulk.

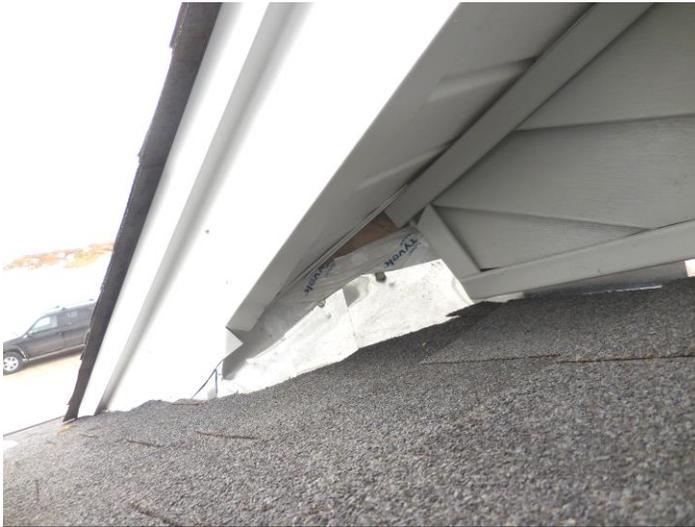
Repair: There is a very poor flashing detail on the roof over the front porch where this roof meets the garage roof. The different pitches of the two roofs have created a small alcove only visible from the porch roof (it can also be seen from the middle bedroom window). This installer used

some step flashing and Tyvek tape in an effort to seal the area, but left some of the sheathing exposed. This is poor workmanship that needs to be repaired.

A very poor flashing detail was found on the roof over the front entry porch.

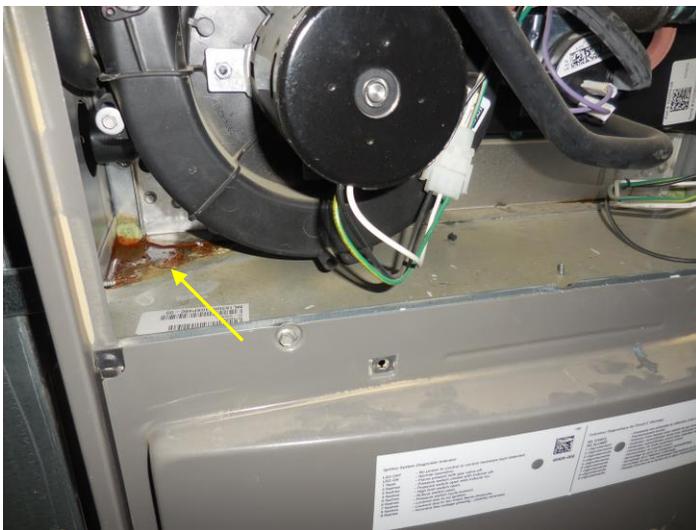
Condensate was dripping into the furnace cabinet from somewhere behind the inducer motor.

Repair: Condensate was found dripping into the furnace cabinet from somewhere behind the inducer motor and needs to be repaired.

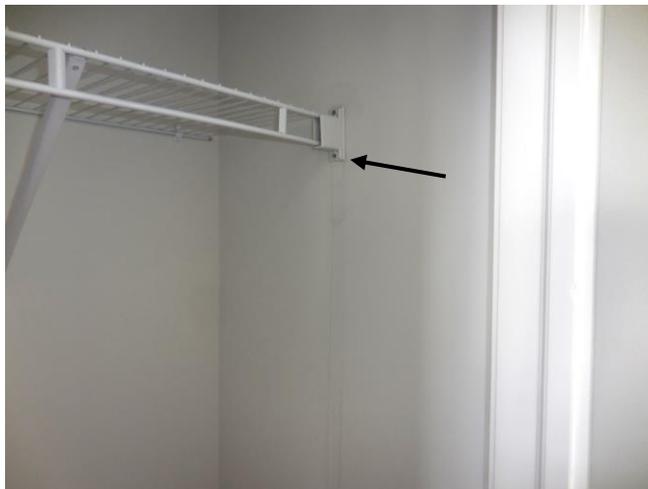
Water poured out from behind this shelf cleat in the main level closet when the 2nd floor fixtures were operated.

Repair: Water was found dripping into the basement from the area where the 3" waste line for the 2nd floor bathrooms enters the basement ceiling. While searching for the source of

the leak, I found that water was dripping from a shelf cleat in the main level coat closet; the same wall that the waste stack is located. To confirm that this was the source of the leak, the water in these bathrooms was operated again and water was found pouring out of the cleat. It looks as if the shelf installer drilled into the waste stack.

The wall needs to be opened and the damaged section of piping needs to be replaced. Please note that replacement is the only repair that I recommend. Any type of patching can eventually fail.

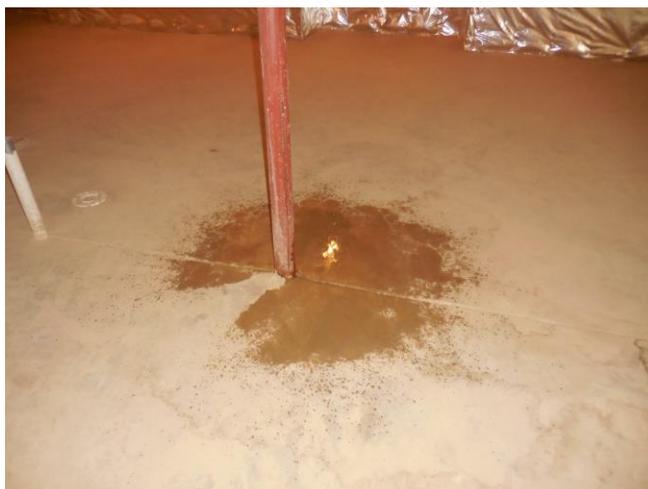
This is the result of the leak.
