HOME INSPECTIONS, INC.

Building Inspection Report

1010 Main St. Anywhere, USA

Inspection Date:
2/17/2015

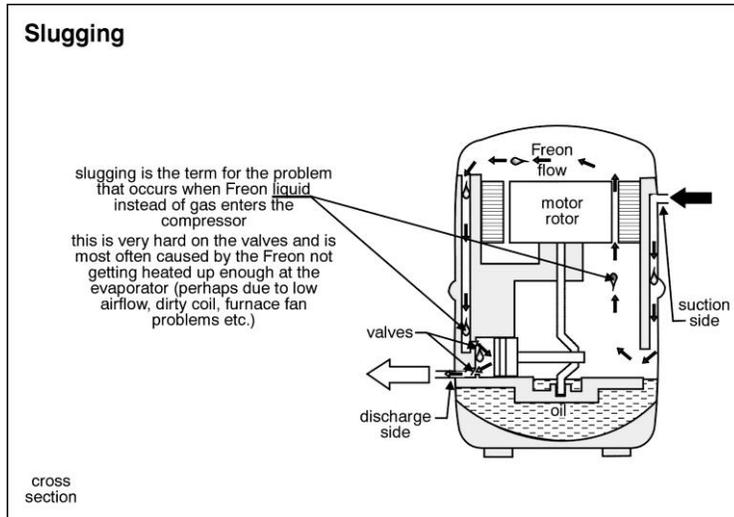
COOLING

Due to the colder temperatures, operating the AC system was not possible. Operating the system when temperatures fall below 60 degrees could possibly damage the compressor (the outside temperature was 18° at the start of the inspection). The term for this is called “slugging”. This is when the refrigerant does not completely boil off, which can damage the compressor.

The average life expectancy of an air conditioning compressor (the heart of the A.C. system) is in the 15 to 17 year range. Keep the cooling coils of the condenser clean and change filter at the air handler regularly. Also annual servicing is needed to keep the system operating as efficiently as possible.
